WILLIAMS DAM

JEFFERSON COUNTY, MISSOURI

MO 30384

**PHASE 1 INSPECTION REPORT
NATIONAL DAM SAFETY PROGRAM**

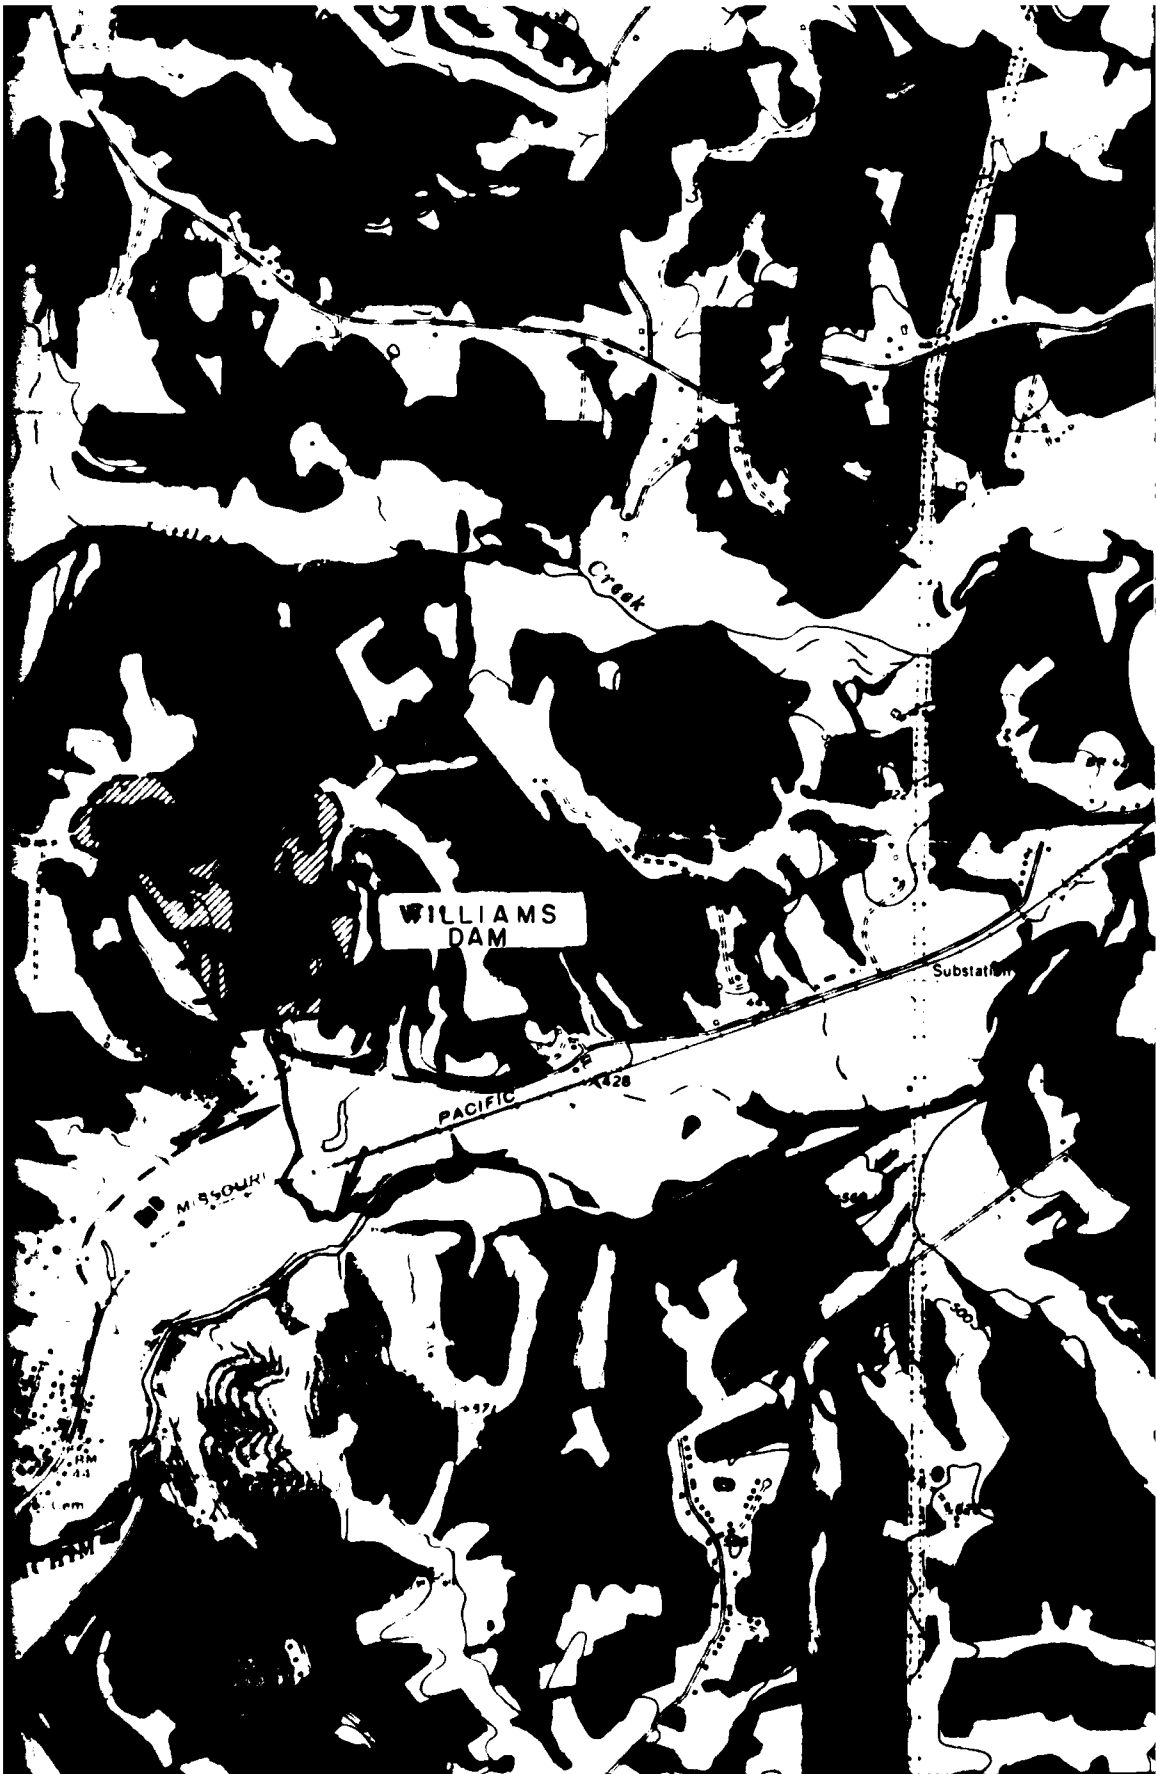
PLAN OF DAM AND SPILLWAY

(2) The east spillway channel is in good condition. However, the berm along the west side of the exit channel is low. Maximum spillway discharges will overflow and erode this berm at its upper end near the dam and may endanger the dam embankment.

(3) The west spillway crest is at too high an elevation to be effective in discharging water before the dam is overtopped.

a. Alternatives Spillway size and/or height of dam should be increased to prevent overtopping by the probable maximum flood. The owner should obtain the services of an experienced engineer to design and observe construction of remedial measures.
